**Flood Control Project Maintenance
Levee Inspections**

Spring 2010 Levee Inspection Results

Reclamation District No. 0563 Tyler Island

Levee Inspection Report By Mile - Spring 2010

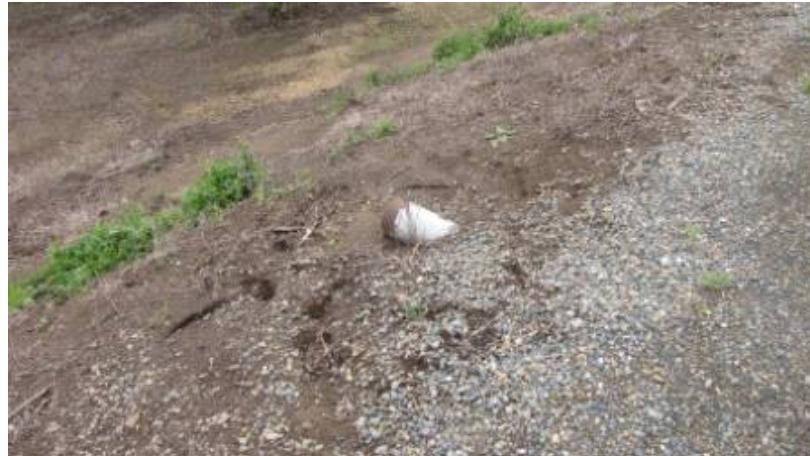
Levee Mile Report Line	8
Start Levee Mile	0.96
End Levee Mile	0.96
Location	Land Side
Category	Earthen Levee
Item	Encroachments
Looking at pipe on landside slope.	
<i>richard_s_20100510_066.jpg</i>

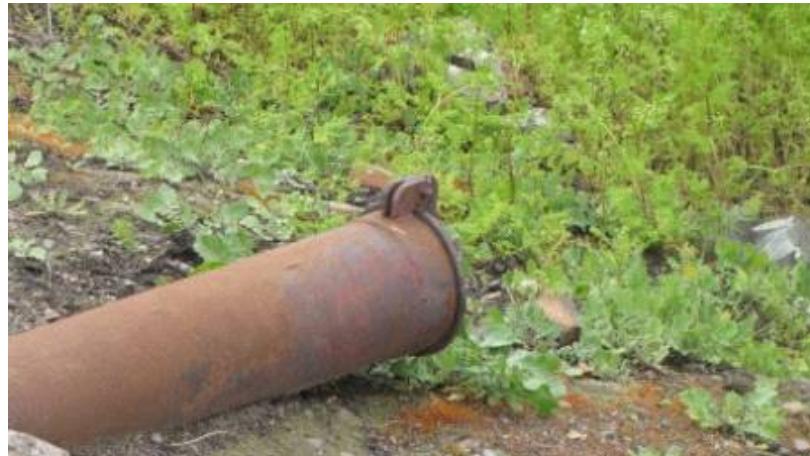
Levee Mile Report Line	8
Start Levee Mile	0.96
End Levee Mile	0.96
Location	Land Side
Category	Earthen Levee
Item	Encroachments
Looking at pipe on waterside slope.	
<i>richard_s_20100510_067.jpg</i>

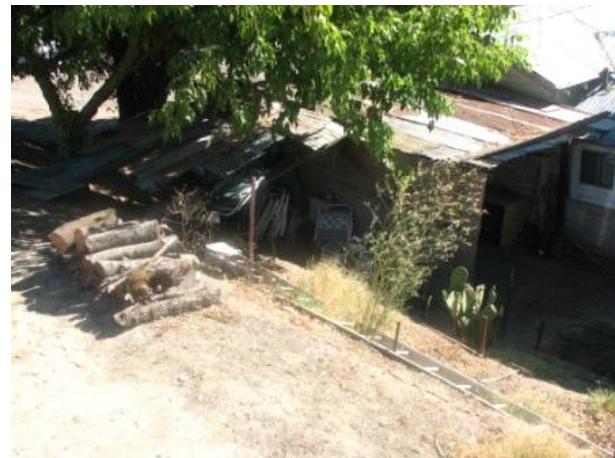
Levee Mile Report Line	14
Start Levee Mile	1.25
End Levee Mile	1.25
Location	Land Side
Category	Earthen Levee
Item	Encroachments
Looking at shed at landside toe.	
<i>richard_s_20100505_045.jpg</i>

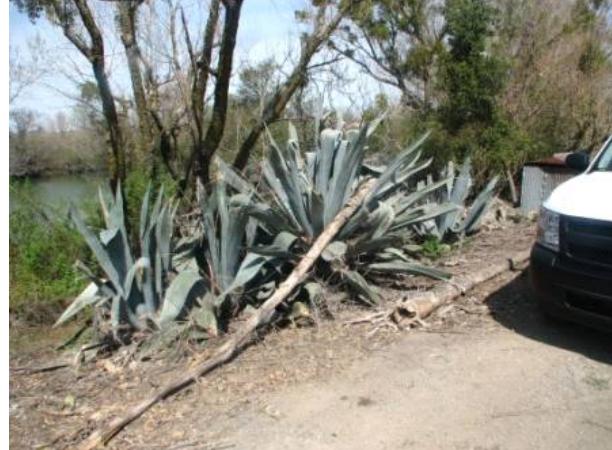
Levee Mile Report Line	16
Start Levee Mile	1.44
End Levee Mile	1.48
Location	Water Side
Category	Earthen Levee
Item	Vegetation
Century plant on waterward shoulder at LM 1.42	
richard_s_20100505_038.jpg

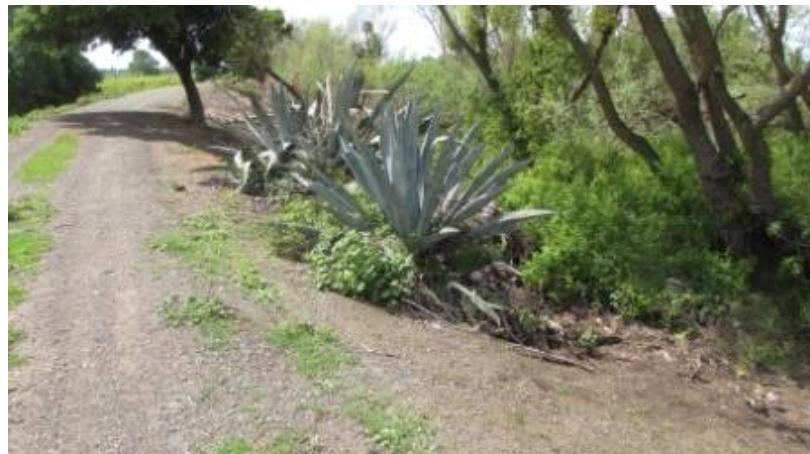
Levee Mile Report Line	16
Start Levee Mile	1.44
End Levee Mile	1.48
Location	Water Side
Category	Earthen Levee
Item	Vegetation
Looking upstream at updated century plant on waterside shoulder slope.	
richard_s_20100510_069.jpg

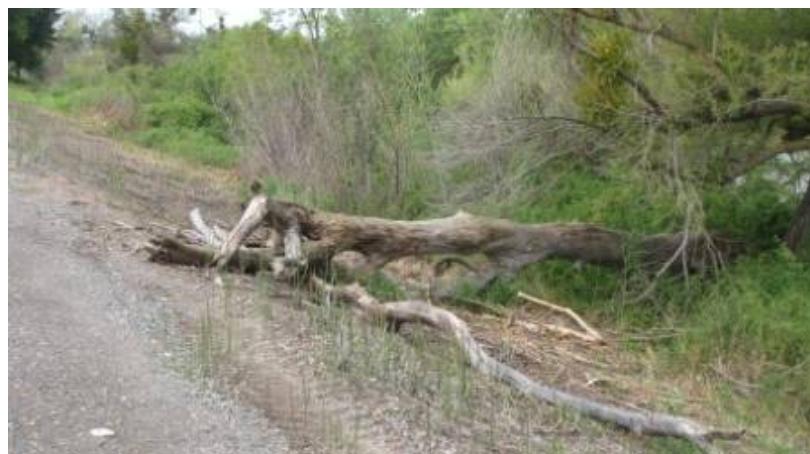
Levee Mile Report Line	17
Start Levee Mile	1.46
End Levee Mile	1.46
Location	Water Side
Category	Earthen Levee
Item	Encroachments
Looking at tree limb on waterside slope.	
richard_s_20100510_068.jpg

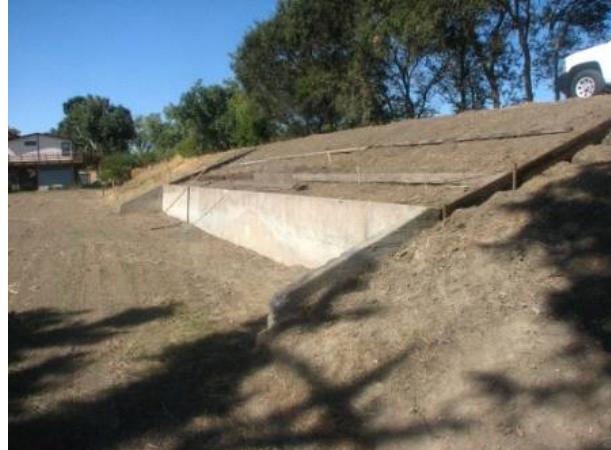
Levee Mile Report Line	18
Start Levee Mile	1.86
End Levee Mile	1.86
Location	Land Side
Category	Earthen Levee
Item	Encroachments
Unauthorized retaining wall on landside toe.	
richard_s_20100505_046.jpg

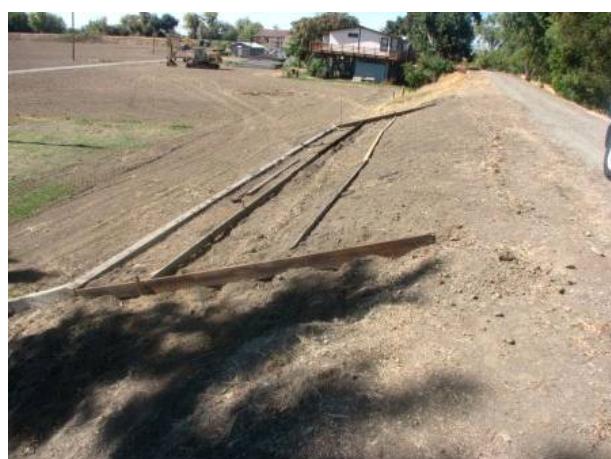
Levee Mile Report Line	18
Start Levee Mile	1.86
End Levee Mile	1.86
Location	Land Side
Category	Earthen Levee
Item	Encroachments
Flower box above retaining wall on landside slope	
richard_s_20100505_047.jpg

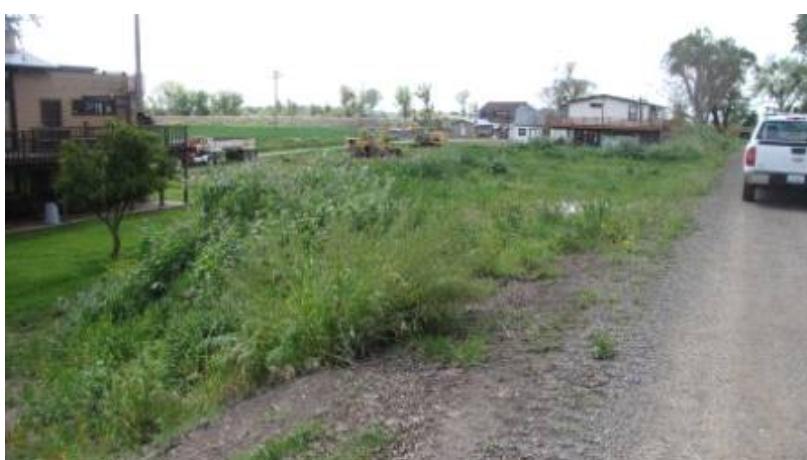
Levee Mile Report Line	18
Start Levee Mile	1.86
End Levee Mile	1.86
Location	Land Side
Category	Earthen Levee
Item	Encroachments
Looking upstream at earthen pad on landside shoulder covering retaining wall and flower box.	
richard_s_20100510_070.jpg

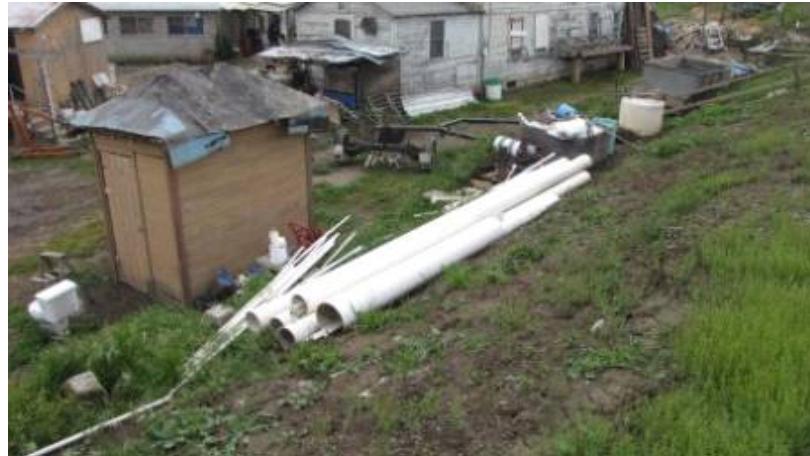
Levee Mile Report Line	19
Start Levee Mile	1.96
End Levee Mile	1.98
Location	Land Side
Category	Earthen Levee
Item	Encroachments
Looking southeast at material and equipment on landside slope and toe.	
richard_s_20100510_072.jpg

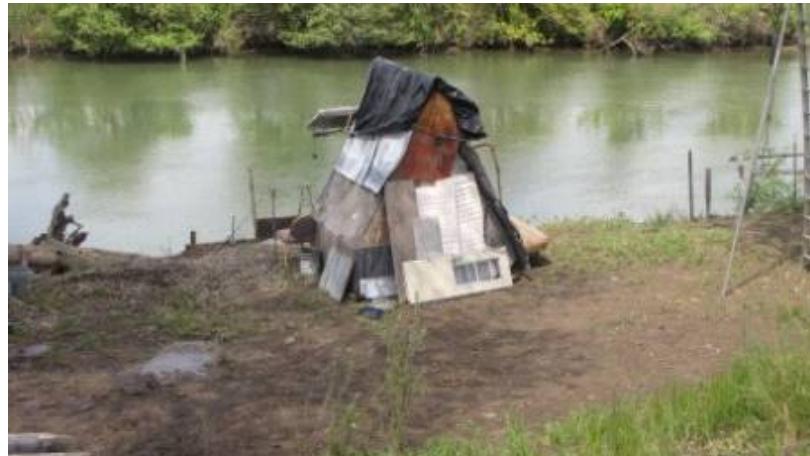
Levee Mile Report Line	20
Start Levee Mile	1.97
End Levee Mile	1.97
Location	Water Side
Category	Earthen Levee
Item	Encroachments
Looking west at shed on waterside berm.	
richard_s_20100510_071.jpg

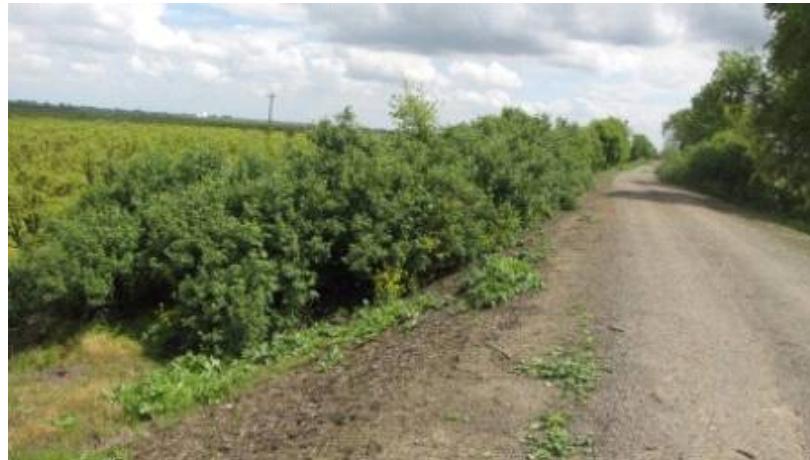
Levee Mile Report Line	23
Start Levee Mile	2.44
End Levee Mile	2.45
Location	Land Side
Category	Earthen Levee
Item	Vegetation
Looking southeast at elderberry on the landside slope and toe.	
richard_s_20100510_073.jpg

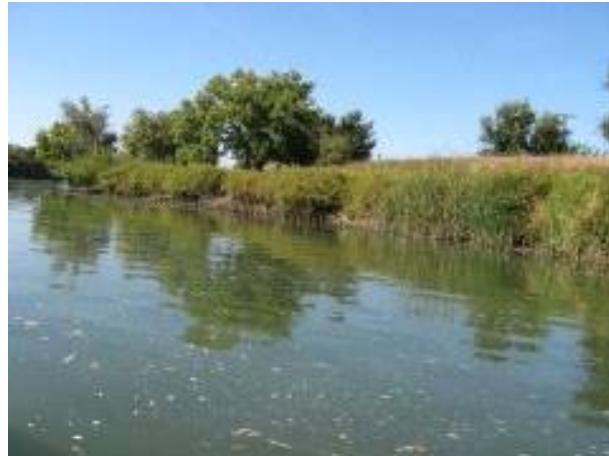
Levee Mile Report Line	28
Start Levee Mile	2.68
End Levee Mile	2.87
Location	Water Side
Category	Supplemental
Item	USACE Erosion Survey
2009: 10 ft berm, 1:1 slope, no stability issues, clays and silts, 1.07 ft/s [2009 SiteID:GEO_9-3_L]	
USACE2009_GEO_9-3_L_2009_09_18-D4P88_small.JPG

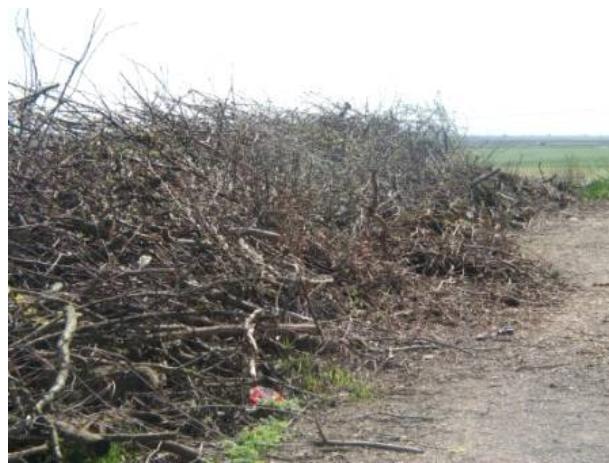
Levee Mile Report Line	31
Start Levee Mile	2.94
End Levee Mile	2.95
Location	Land Side
Category	Earthen Levee
Item	Encroachments
Prunings on landward shoulder from LM 2.93 to 2.95	
richard_s_20100505_039.jpg

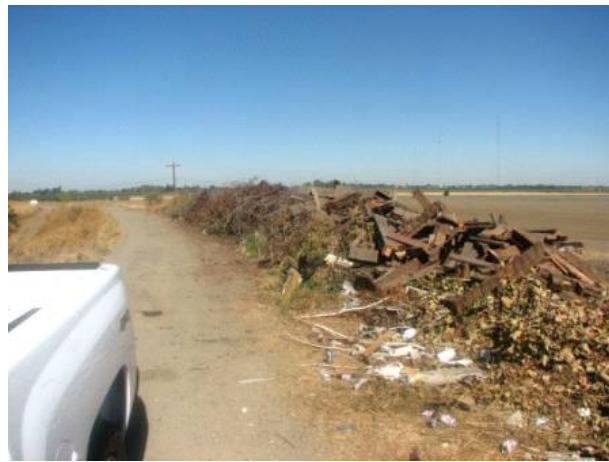
Levee Mile Report Line	31
Start Levee Mile	2.94
End Levee Mile	2.95
Location	Land Side
Category	Earthen Levee
Item	Encroachments
View looking upstream at pruning pile.	
richard_s_20100505_040.jpg

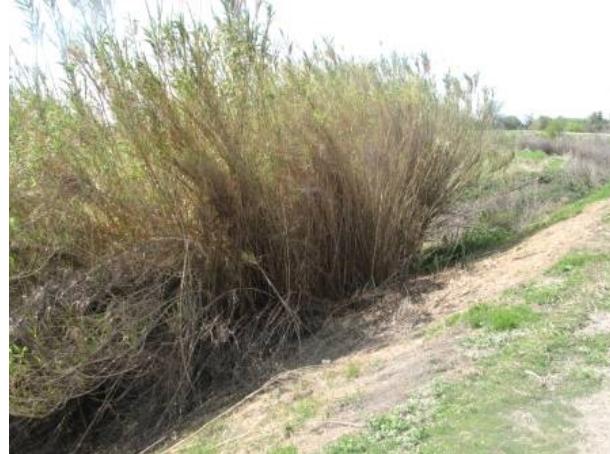
Levee Mile Report Line	32
Start Levee Mile	3.06
End Levee Mile	3.12
Location	Land Side
Category	Earthen Levee
Item	Vegetation
Bamboo at landward toe at LM 3.05	
richard_s_20100505_041.jpg

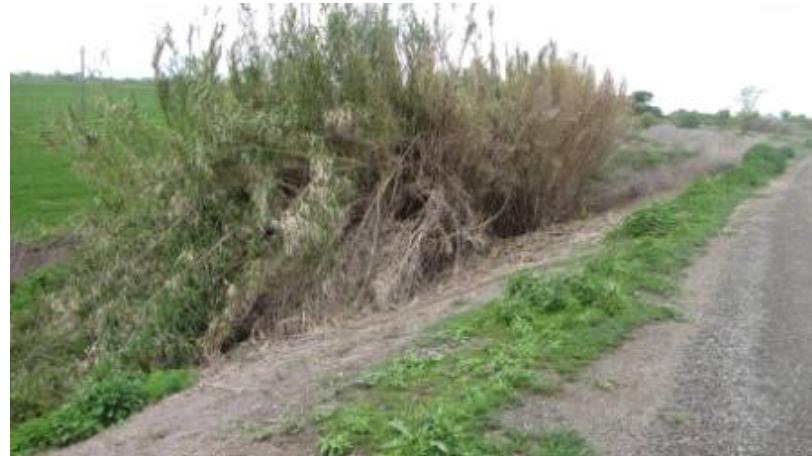
Levee Mile Report Line	32
Start Levee Mile	3.06
End Levee Mile	3.12
Location	Land Side
Category	Earthen Levee
Item	Vegetation
Looking southeast at updated view of bamboo on landside slope and toe.	
richard_s_20100510_074.jpg

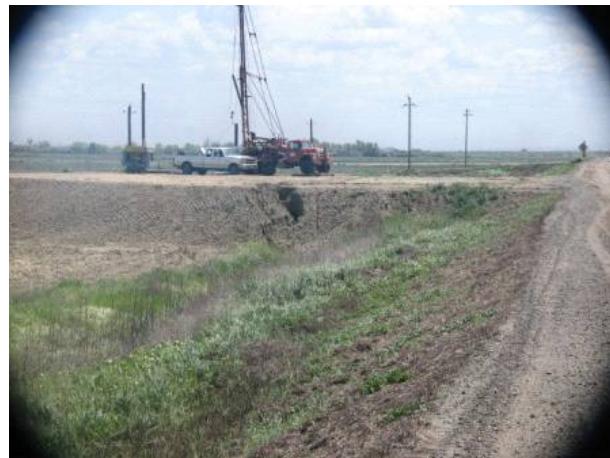
Levee Mile Report Line	37
Start Levee Mile	3.63
End Levee Mile	3.65
Location	Land Side
Category	Earthen Levee
Item	Encroachments
Looking upstream at building pad at landside slope. Pad is approx. 100' x 100'	
richard_s_20100505_050.jpg

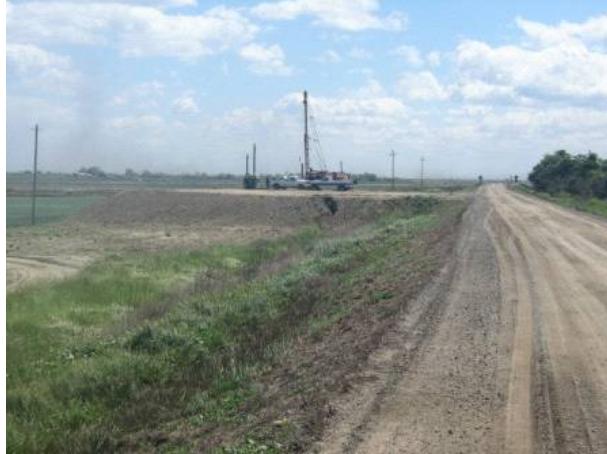
Levee Mile Report Line	37
Start Levee Mile	3.63
End Levee Mile	3.65
Location	Land Side
Category	Earthen Levee
Item	Encroachments

Looking upstream at house pad on landside slope.

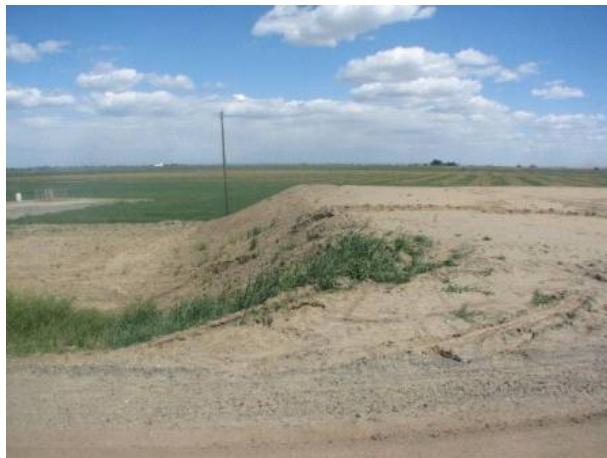
Levee Mile Report Line	37
Start Levee Mile	3.63
End Levee Mile	3.65
Location	Land Side
Category	Earthen Levee
Item	Encroachments

Looking east at left corner of house pad.

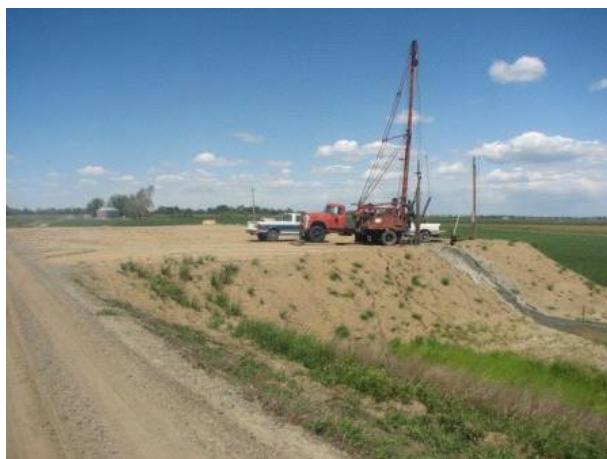
Levee Mile Report Line	37
Start Levee Mile	3.63
End Levee Mile	3.65
Location	Land Side
Category	Earthen Levee
Item	Encroachments

Looking downstream at house pad with utility pole and drilling rig on the landside of levee.

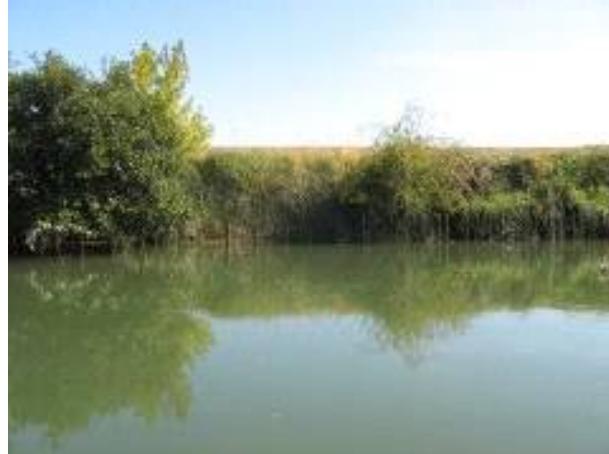
Levee Mile Report Line	38
Start Levee Mile	4.00
End Levee Mile	4.02
Location	Water Side
Category	Supplemental
Item	USACE Erosion Survey
2009: 15 ft berm, 1.5:1 slope, no stability issues, clays and silts, 3.68 ft/s [2009 SiteID:GEO_8-3_L]	
USACE2009_GEO_8-3_L_2009_09_18-D4P87_small.JPG

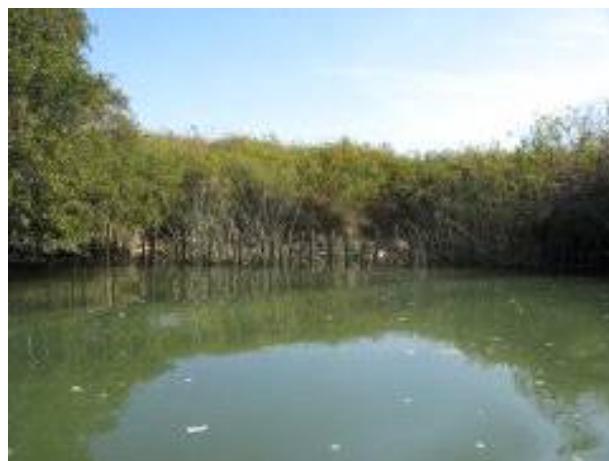
Levee Mile Report Line	39
Start Levee Mile	5.12
End Levee Mile	5.16
Location	Water Side
Category	Supplemental
Item	USACE Erosion Survey
2009: no berm, 2:1 slope, no stability issues, clays and silts, 3.71 ft/s [2009 SiteID:GEO_7-2_L]	
USACE2009_GEO_7-2_L_2009_09_18-D4P86_small.JPG

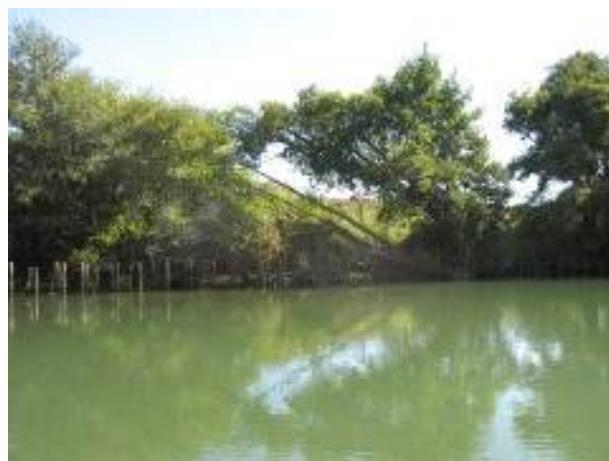
Levee Mile Report Line	40
Start Levee Mile	5.29
End Levee Mile	5.52
Location	Water Side
Category	Supplemental
Item	USACE Erosion Survey
2009: 10 ft berm, 1.5:1 slope, tree hazards and holes, clays and silts, 3.78 ft/s [2009 SiteID:GEO_6-8_L]	
USACE2009_GEO_6-8_L_2009_09_18-D4P83_small.JPG

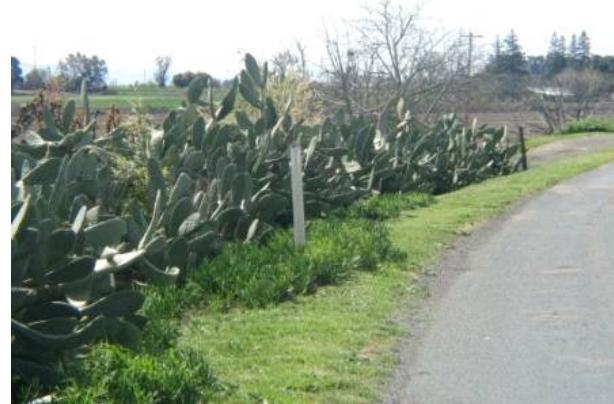
Levee Mile Report Line	44
Start Levee Mile	6.04
End Levee Mile	6.08
Location	Land Side
Category	Earthen Levee
Item	Vegetation
Large Cactus plant on landward slope from LM 6.04 to 6.08	
richard_s_20100505_042.jpg

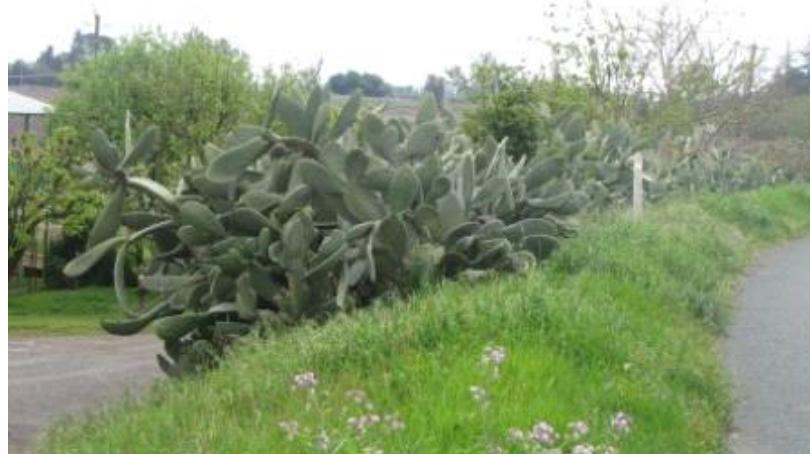
Levee Mile Report Line	44
Start Levee Mile	6.04
End Levee Mile	6.08
Location	Land Side
Category	Earthen Levee
Item	Vegetation
Looking at north end of catcus on the landside slope.	
richard_s_20100510_075.jpg

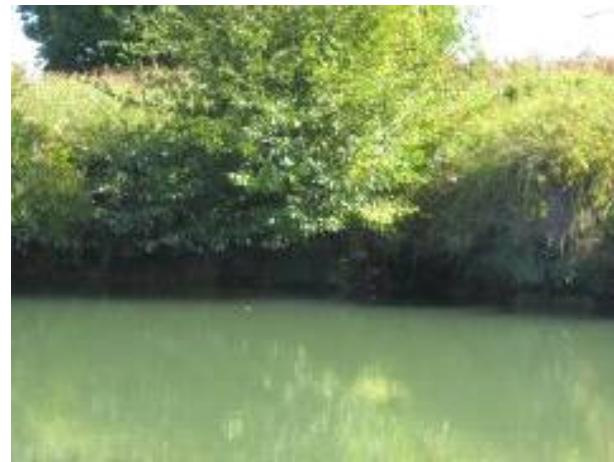
Levee Mile Report Line	45
Start Levee Mile	6.07
End Levee Mile	6.41
Location	Water Side
Category	Supplemental
Item	USACE Erosion Survey
2009: 10 ft berm, 1.5:1 slope, tree hazards, clays and silts, 3.95 ft/s [2009 SiteID:GEO_6-1_L]	
USACE2009_GEO_6-1_L_2009_09_18-D4P73_small.JPG

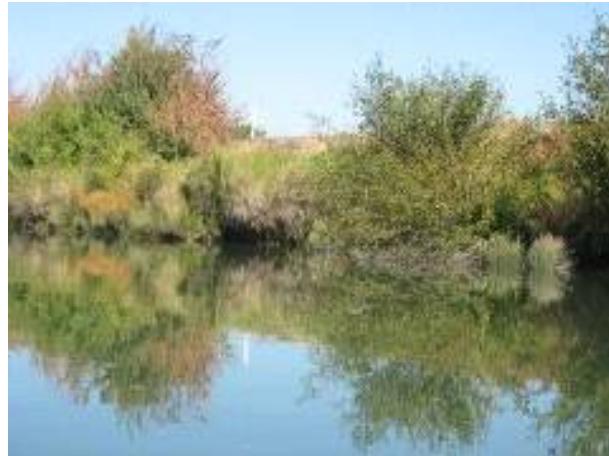
Levee Mile Report Line	54
Start Levee Mile	6.83
End Levee Mile	7.44
Location	Water Side
Category	Supplemental
Item	USACE Erosion Survey
2009: 5 ft berm, 1.5:1 slope, tree hazards and holes, clays and silts, 3.95 ft/s [2009 SiteID:GEO_5-3_L]	
USACE2009_GEO_5-3_L_2009_09_18-D4P69_small.JPG

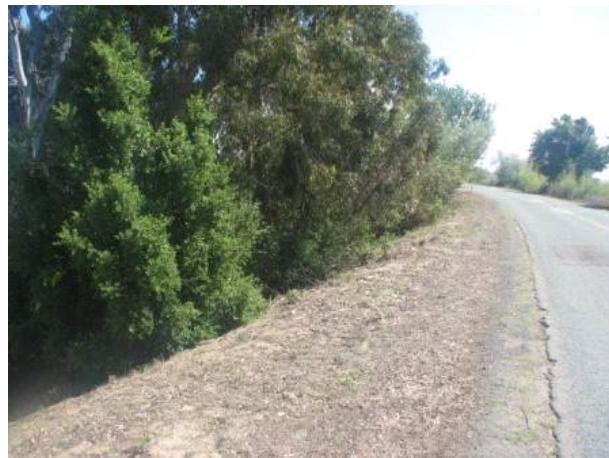
Levee Mile Report Line	55
Start Levee Mile	6.90
End Levee Mile	6.94
Location	Land Side
Category	Earthen Levee
Item	Trim / Thin Trees
Side view of dense trees along landside slope and shoulder.	
richard_s_20100505_043.jpg

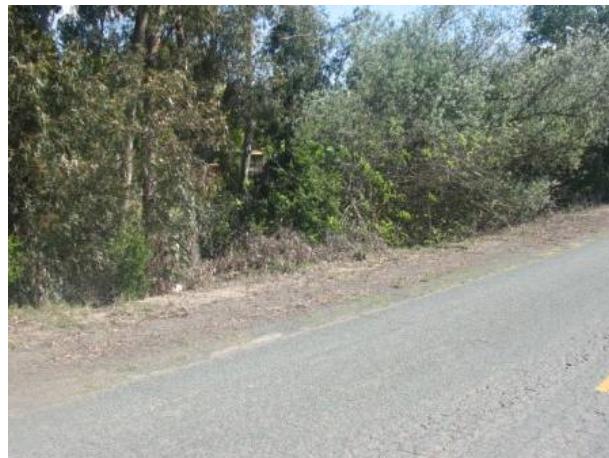
Levee Mile Report Line	55
Start Levee Mile	6.90
End Levee Mile	6.94
Location	Land Side
Category	Earthen Levee
Item	Trim / Thin Trees
Front view of dense trees along landside shoulder and slope.	
richard_s_20100505_044.jpg

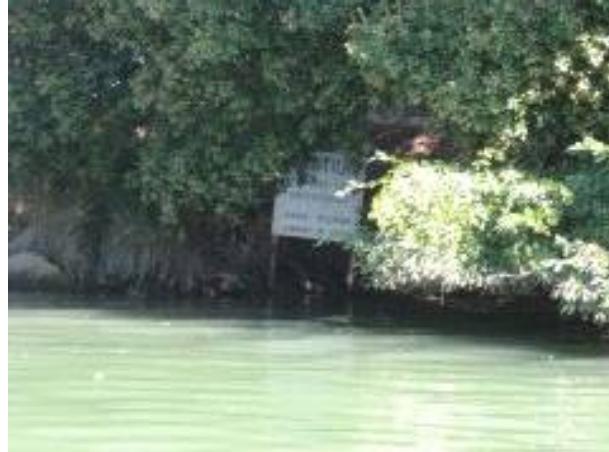
Levee Mile Report Line	57
Start Levee Mile	7.70
End Levee Mile	7.92
Location	Water Side
Category	Supplemental
Item	USACE Erosion Survey
2009: 5 ft berm, 1.5:1 slope, tree hazards, clays and silts, 3.94 ft/s [2009 SiteID:GEO_4-6_L]	
USACE2009_GEO_4-6_L_2009_09_18-D4P63_small.JPG

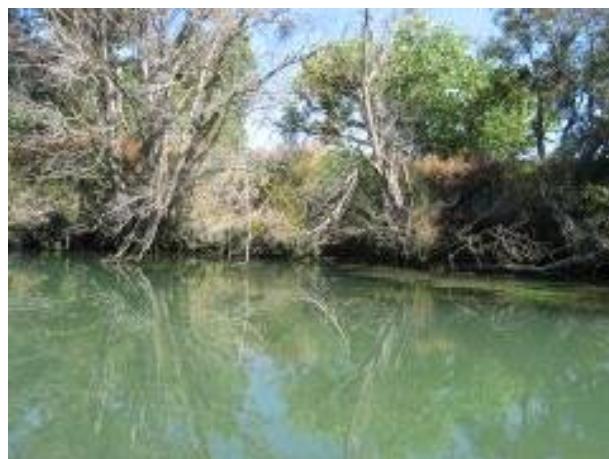
Levee Mile Report Line	60
Start Levee Mile	7.93
End Levee Mile	7.97
Location	Water Side
Category	Supplemental
Item	USACE Erosion Survey
2009: 5 ft berm, 1.5:1 slope, tree hazards, clays and silts, 4.01 ft/s [2009 SiteID:GEO_4-5_L]	
USACE2009_GEO_4-5_L_2009_09_18-D4P61_small.JPG

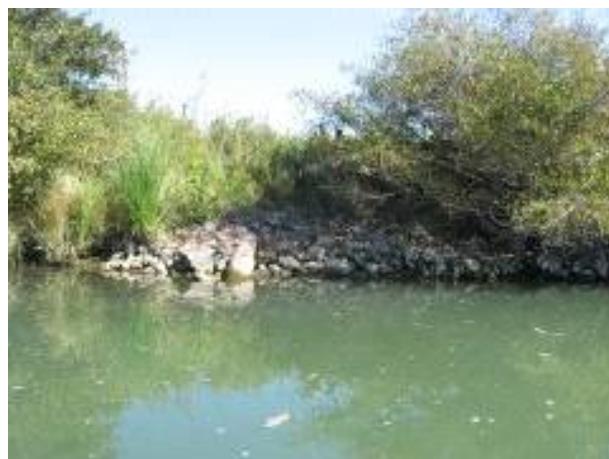
Levee Mile Report Line	61
Start Levee Mile	8.04
End Levee Mile	8.23
Location	Water Side
Category	Supplemental
Item	USACE Erosion Survey
2009: 5 ft berm, 1.5:1 slope, no stability issues, clays and silts, 4.02 ft/s [2009 SiteID:GEO_4-3_L]	
USACE2009_GEO_4-3_L_2009_09_18-D4P56_small.JPG

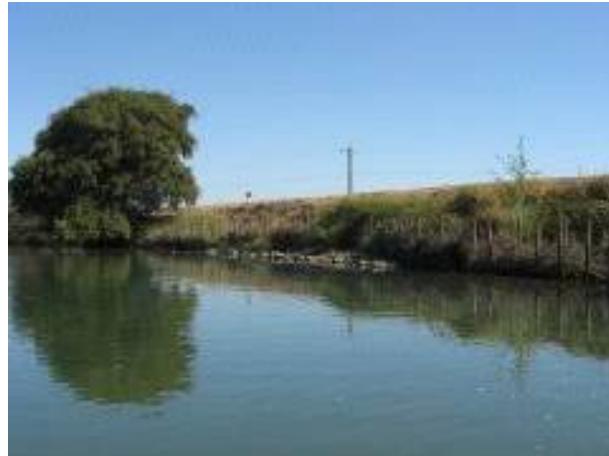
Levee Mile Report Line	62
Start Levee Mile	8.29
End Levee Mile	8.39
Location	Water Side
Category	Supplemental
Item	USACE Erosion Survey
2009: 5 ft berm, 1:1 slope, no stability issues, clays and silts, 3.76 ft/s [2009 SiteID:GEO_4-0_L]	
USACE2009_GEO_4-0_L_2009_09_18-D4P53_small.JPG

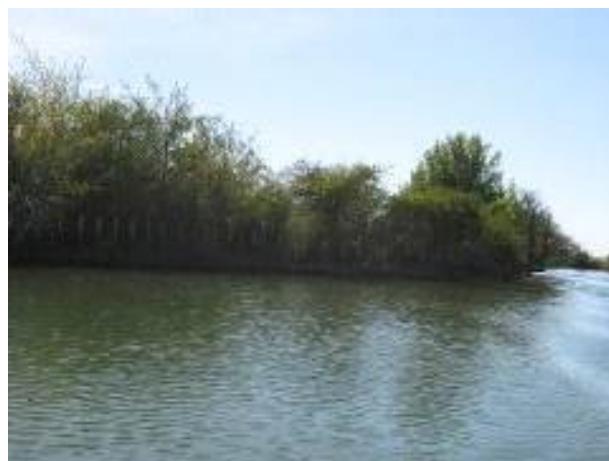
Levee Mile Report Line	63
Start Levee Mile	8.40
End Levee Mile	8.48
Location	Water Side
Category	Supplemental
Item	USACE Erosion Survey
2009: 5 ft berm, 2:1 slope, holes, sands and silts, 4.04 ft/s [2009 SiteID:GEO_3-71_L]	
USACE2009_GEO_3-71_L_2009_09_18-D4P51_small.JPG

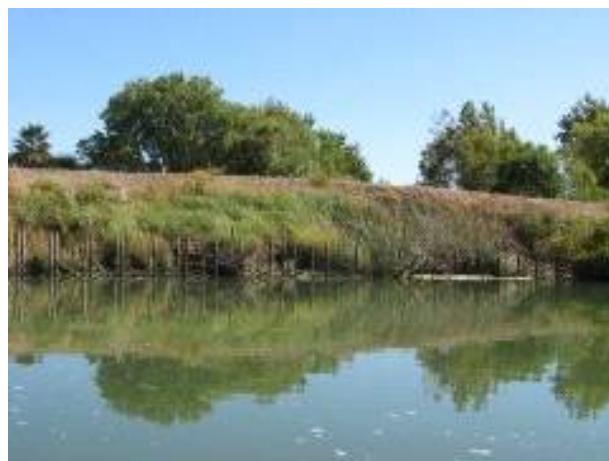
Levee Mile Report Line	64
Start Levee Mile	8.50
End Levee Mile	8.53
Location	Water Side
Category	Supplemental
Item	USACE Erosion Survey
2009: 5 ft berm, 2:1 slope, holes, sands and silts, 4.64 ft/s [2009 SiteID:GEO_3-7_L]	
USACE2009_GEO_3-7_L_2009_09_18-D4P50_small.JPG

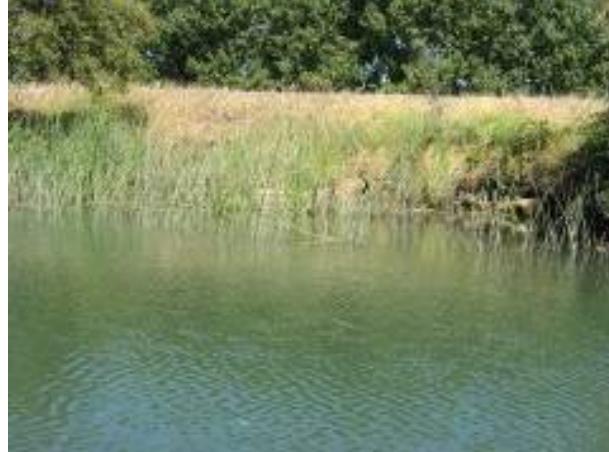
Levee Mile Report Line	65
Start Levee Mile	8.55
End Levee Mile	8.75
Location	Water Side
Category	Supplemental
Item	USACE Erosion Survey
2009: 5 ft berm, 2:1 slope, holes, clays and silts, 4.04 ft/s [2009 SiteID:GEO_3-6_L]	
USACE2009_GEO_3-6_L_2009_09_18-D4P47_small.JPG

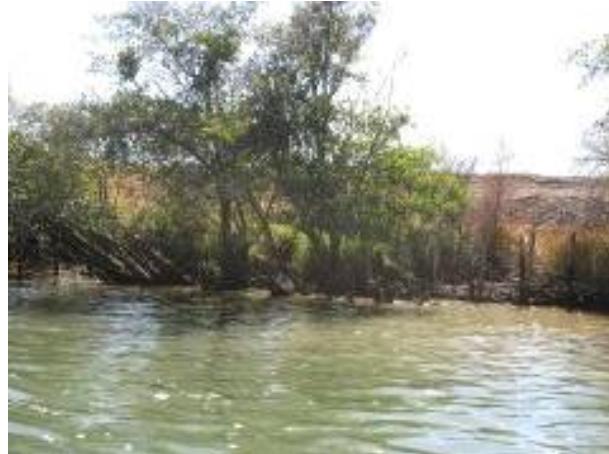
Levee Mile Report Line	73
Start Levee Mile	9.90
End Levee Mile	9.96
Location	Water Side
Category	Supplemental
Item	USACE Erosion Survey
2009: 5 ft berm, 2.5:1 slope, no stability issues, clays and silts, 3.99 ft/s [2009 SiteID:GEO_2-5_L]	
USACE2009_GEO_2-5_L_2009_09_18-D4P46_small.JPG

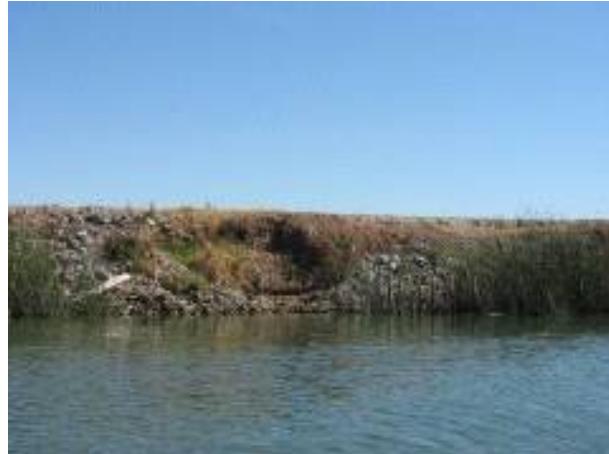
Levee Mile Report Line	76
Start Levee Mile	10.33
End Levee Mile	10.44
Location	Water Side
Category	Supplemental
Item	USACE Erosion Survey
2009: no berm, 2:1 slope, no stability issues, clays and silts, 4.01 ft/s [2009 SiteID:GEO_2-0_L]	
USACE2009_GEO_2-0_L_2009_09_18-D4P44_small.JPG

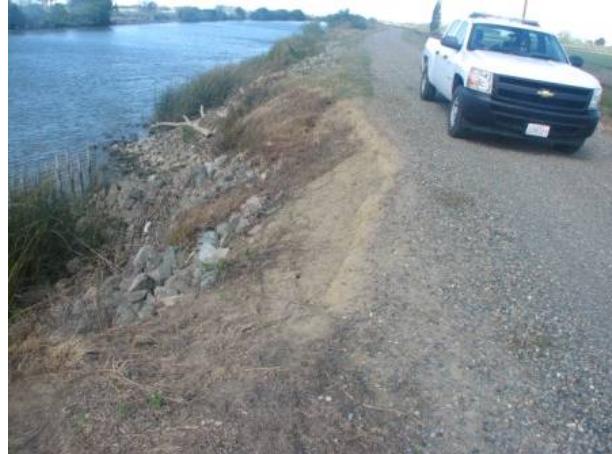
Levee Mile Report Line	77
Start Levee Mile	10.44
End Levee Mile	10.44
Location	Water Side
Category	Earthen Levee
Item	Erosion / Bank Caving
Looking downstream at erosion site on waterside slope and shoulder.	
richard_s_20100505_056.jpg

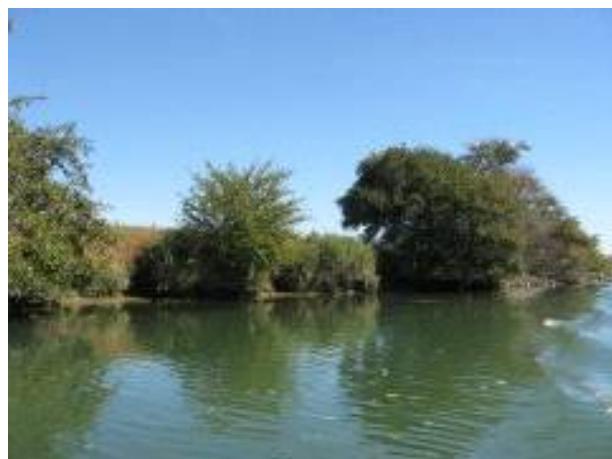
Levee Mile Report Line	79
Start Levee Mile	10.63
End Levee Mile	10.89
Location	Water Side
Category	Supplemental
Item	USACE Erosion Survey
2009: 5 ft berm, 2:1 slope, holes, clays and silts, 4.05 ft/s [2009 SiteID:GEO_1-7_L]	
USACE2009_GEO_1-7_L_2009_09_18-D4P42_small.JPG

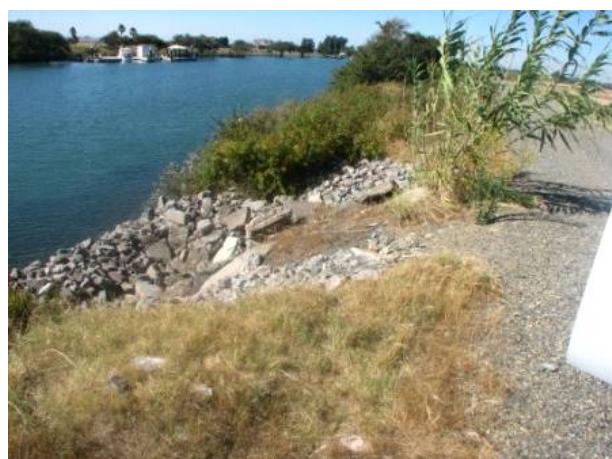
Levee Mile Report Line	80
Start Levee Mile	10.90
End Levee Mile	10.90
Location	Water Side
Category	Earthen Levee
Item	Slope Stability
Uncompleted slope stability repair on waterside slope.	
richard_s_20100505_049.jpg

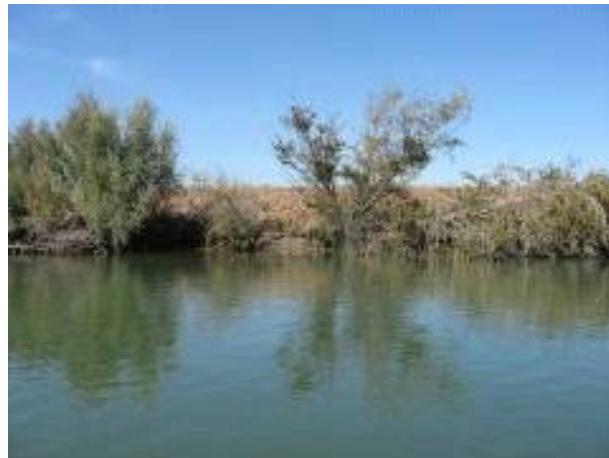
Levee Mile Report Line	84
Start Levee Mile	11.69
End Levee Mile	12.04
Location	Water Side
Category	Supplemental
Item	USACE Erosion Survey
2009: 5 ft berm, 1.5:1 slope, tree hazards and slumping, clays and silts, 4.63 ft/s [2009 SiteID:GEO_0-3_L]	
USACE2009_GEO_0-3_L_2009_09_18-D4P39_small.JPG

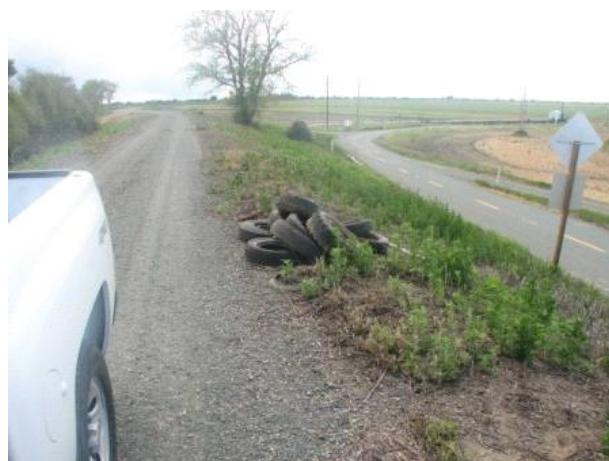
Levee Mile Report Line	87
Start Levee Mile	12.26
End Levee Mile	12.26
Location	Land Side
Category	Earthen Levee
Item	Encroachments
Rubber tires on landside shoulder.	
richard_s_20100505_057.jpg
